**Flood Control Project Maintenance
Levee Inspections**
LMA District Cover Sheet
Spring 2019 Levee Inspection Results

Reclamation District No. 2064 River Junction

Spring 2019 Levee Inspection Results

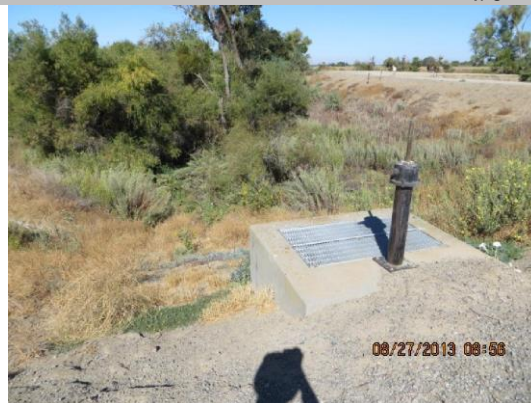
Photo 1 of 3 : UCIP_SP_2019_43603_31258.jpg

Slide gate in concrete riser on WS shoulder.

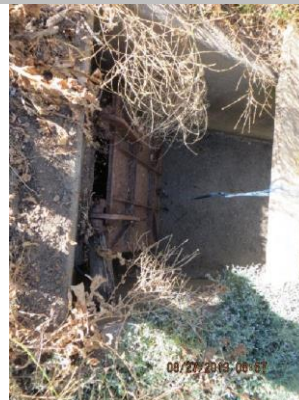
Photo 2 of 3 : UCIP_SP_2019_43603_31257.jpg

Flap gate and U shaped headwall on WS toe. Debris blocking closure of gate.

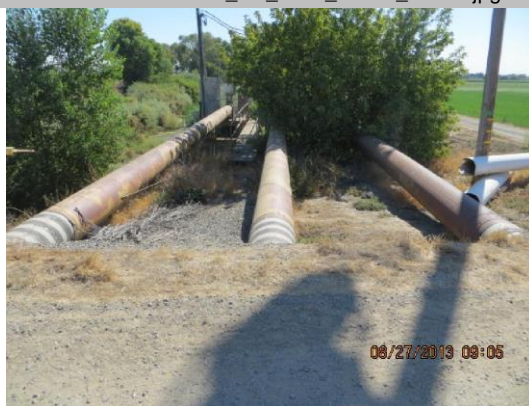
Photo 1 of 3 : UCIP_SP_2019_22729_38458.jpg

Pipe visible on LS.

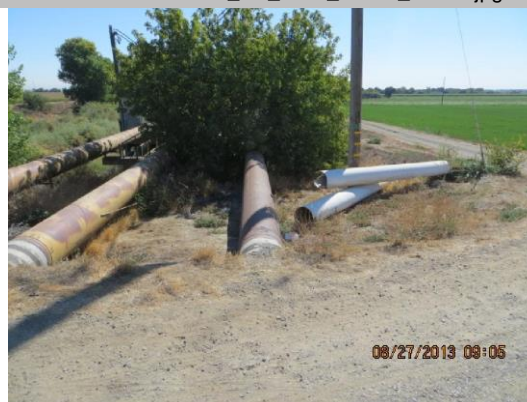
Photo 1 of 3 : UCIP_SP_2019_18720_31294.jpg

LM Start	0.06	Rating **	M	Issue No.	39
LM End	0.06	Issue Type +	En	Location *	
Category	Supplemental			GPS Latitude/Longitude	
				Start	End
Item	DWR UCIP Field Study			37.709672 °	37.709672 °
				-121.267532 °	-121.267532 °
DWR ID	20528				
Comment Code					
Inspector Comment					
FS_ID:18720					
DS_ID:20528					
EP_NO: 13907					
Repair Type: Non-Urgent					
Crossing Status: Found					
UCIP Comments: This pipe has less than 1-foot of cover.					
FIELD_STRUCT_DESC: 3 of 3: 24-inch coated steel drainage discharge pipe through the levee, 1 foot below the crown. Two 100-horsepower and one 75-horsepower pumps on the landside (LS) toe. Siphon breaker on the waterside (WS) shoulder. (Permit No. 13907, 1985 - Reclamation District No. 2064). [Additional Reference(s): DWR Levee Log, 2005].					
FS Date: 8/27/2013

Steel pipe visible on LS.

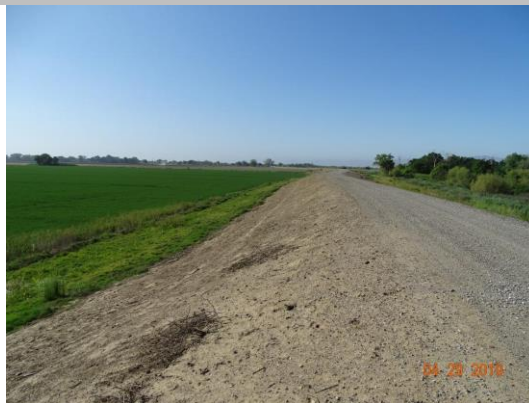
Photo 1 of 1 : SP_2019_RD2064_313_28_20190514_00054.jpg

LM Start	0.17	Rating **	A	Issue No.	28
LM End	5.53	Issue Type +	Ma	Location *	LS
Category	Earthen Levee			GPS Latitude/Longitude	
				Start	End
Item	Vegetation			37.708167 °	37.667557 °
				-121.267857 °	-121.241100 °
DWR ID	DWR_RD2064_01_s_2019_28				
Comment Code					
V1 : Control annual grass and weeds on the levee slopes and easements.					
Inspector Comment					
Annual vegetation is well maintained.

Typical view of vegetation on landside slope. (Spring 2019)

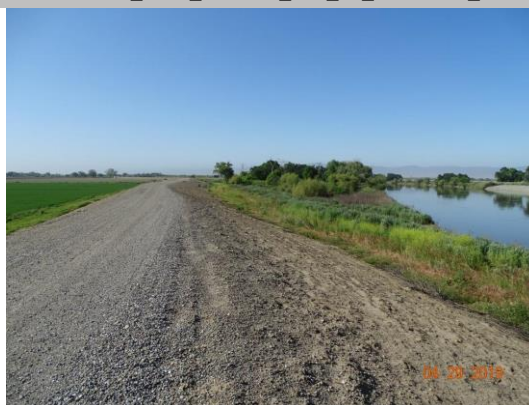
Photo 1 of 1 : SP_2019_RD2064_313_35_20190514_00055.jpg

LM Start	0.17	Rating **	A	Issue No.	35
LM End	5.53	Issue Type +	Ma	Location *	WS
Category	Earthen Levee			GPS Latitude/Longitude	
				Start	End
Item	Vegetation			37.708167 °	37.667557 °
				-121.267857 °	-121.241100 °
DWR ID	DWR_RD2064_01_s_2019_35				
Comment Code					
V1 : Control annual grass and weeds on the levee slopes and easements.					
Inspector Comment					
Annual vegetation is well maintained.

Typical view of vegetation on waterside slope. (Spring 2019)

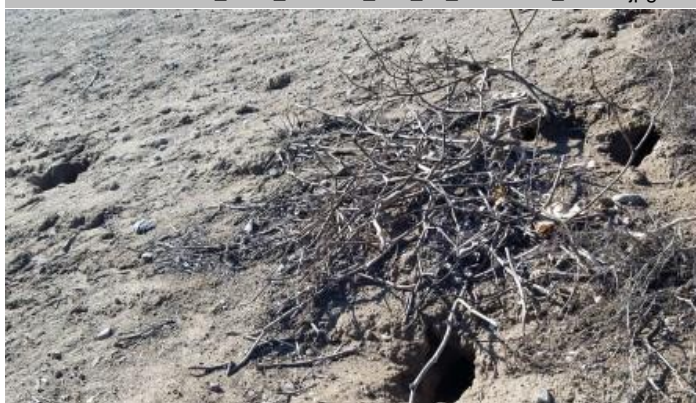
Photo 1 of 1 : SP_2019_RD2064_313_31_20190313_00012.jpg

LM Start	2.14	Rating **	M	Issue No.	31
LM End	2.14	Issue Type +	Ma	Location *	LS
Category	Earthen Levee			GPS Latitude/Longitude	
				Start	End
Item	Animal Control			37.688714 °	37.688714 °
				-121.261480 °	-121.261480 °
DWR ID	DWR_RD2064_01_f_2018_31				
Comment Code					
A3 : No rodents visible, but rodent burrows visible; need to backfill and compact or grout burrows.					
Inspector Comment					
Old rodent holes need to be backfilled.

View of animal holes on levee slope. Fall 2018

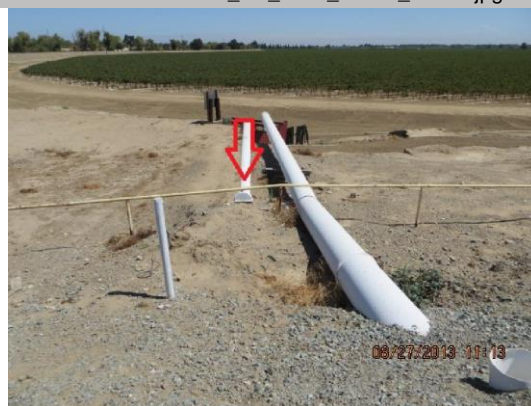
Photo 1 of 3 : UCIP_SP_2019_19044_31844.jpg

Pipe and gate valve on LS toe.

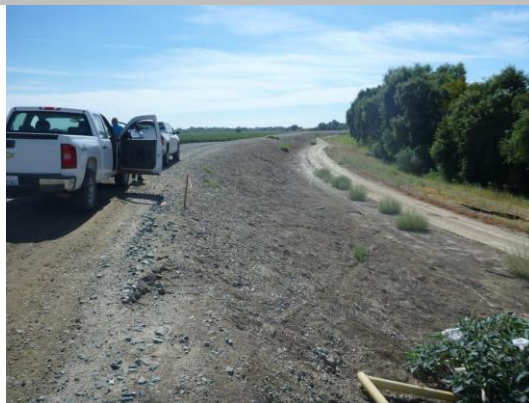
Photo 3 of 3 : SP_2019_RD2064_313_24_20190313_00008.jpg

LM Start	3.92	Rating **	A/W	Issue No.	24 (cont)
LM End	4.03	Issue Type +	Ob	Location *	
Category	Supplemental			GPS Latitude/Longitude	
				Start	End
Item	2017 Storm Damage			37.673190 °	37.672180 °
				-121.258140 °	-121.256490 °
DWR ID	DWR_RD2064_01_f_2017_24				
Comment Code					
Inspector Comment					
Levee Evaluation Comments					
Description:The damaged area is due to extensive seepage occurring from high river flows, especially when the water level is above 25.0' at the Vernalis Gauge. The damage is from long-term saturated soil within the levee structure beyond the landside toe. This area is an extension of a seepage berm placed on an emergency work order in February 2017.					
Site ID No:581					
Site Designation:LMA-487					
Repair Type: Seepage					
Rating:Area of Concern					
Field Date:8/14/2017					
Notes:

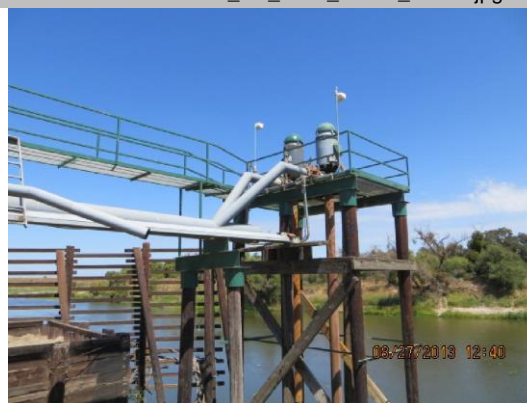
Photo 2 of 2 : UCIP_SP_2019_19064_31862.jpg

Comment Code						
Inspector Comment						
FS_ID:19064 DS_ID:20530 EP_NO: 3359 Repair Type: Non-Urgent Crossing Status: Indicator Found UCIP Comments: Pipe not found. Need to determine disposition of pipe as all other appurtances remain. FIELD_STRUCT_DESC: 2 of 2: 18-inch irrigation pipe of an unknown material through the levee, 3.5 feet below the crown. Pump mounted on pipe structure in the river. Protective fender in the stream. Wooden walkway to the pump structure. Siphon breaker on the landside (LS). (Permit No. 3359, 1960 - Cook Land and Cattle Company). [Additional Reference(s): DWR Levee Log, 2005. USACE San Joaquin O&M Manual 3, December 1968, (HLM 4.69)]. FS Date: 8/27/2013

Pump platform and fender visible on WS toe.

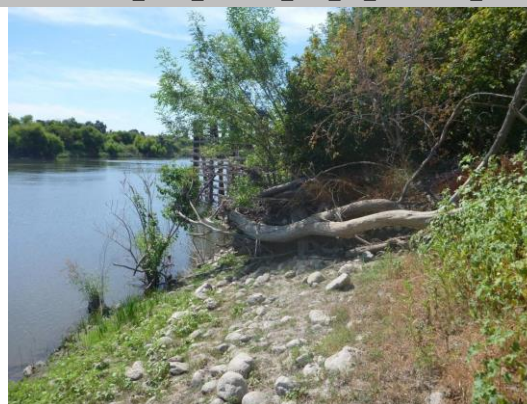
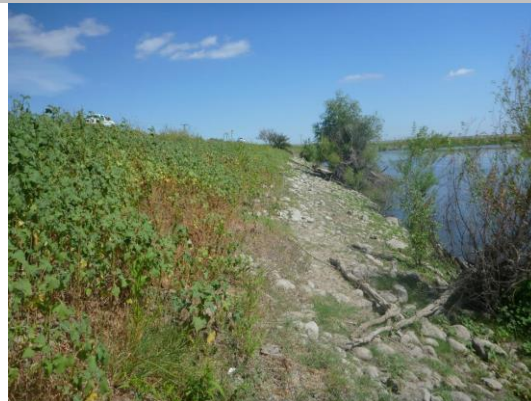
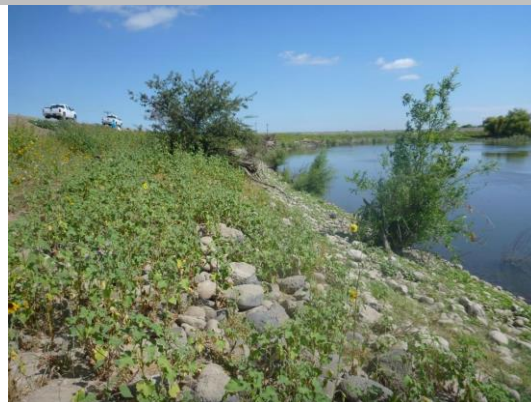
LM Start	4.82	Rating **	A/W	Issue No.	26
LM End	4.85	Issue Type +	Ma	Location *	
Category	Supplemental			GPS Latitude/Longitude	
				Start	End
Item	2017 Storm Damage			37.671730 °	37.672140 °
				-121.246820 °	-121.246800 °
DWR ID	DWR_RD2064_01_f_2017_26				
Comment Code					
Inspector Comment					
Levee Evaluation Comments					
Description:Erosion from high water flows caused erosion scarps from 12" to 24" in height. The area of damage is approximately 600 feet in length.					
Site ID No:583					
Site Designation:LMA-489					
Repair Type: Erosion					
Rating:Area of Concern					
Field Date:8/14/2017					
Notes: Minor toe erosion

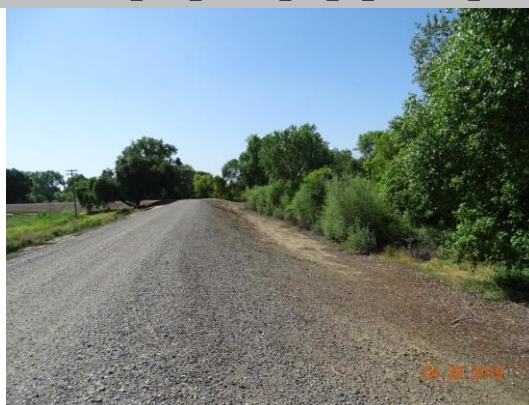
Photo 1 of 1 : SP_2019_RD2064_314_21_20190514_00052.jpg

LM Start	0.00	Rating **	A	Issue No.	21
LM End	5.79	Issue Type +	Ma	Location *	WS
Category	Earthen Levee			GPS Latitude/Longitude	
				Start	End
Item	Vegetation			37.667052 °	37.702842 °
				-121.240932 °	-121.181945 °
DWR ID	DWR_RD2064_02_s_2019_21				
Comment Code					
V1 : Control annual grass and weeds on the levee slopes and easements.					
Inspector Comment					
Annual vegetation is well maintained.

Typical view of vegetation on waterside slope. (Spring 2019)

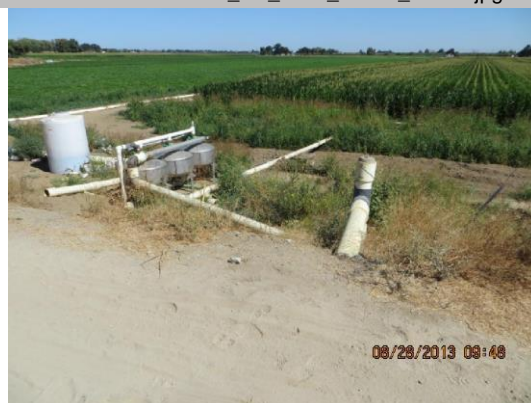
Photo 1 of 3 : UCIP_SP_2019_44653_37715.jpg

Pipe, vent, and filter plant on LS shoulder and LS toe.

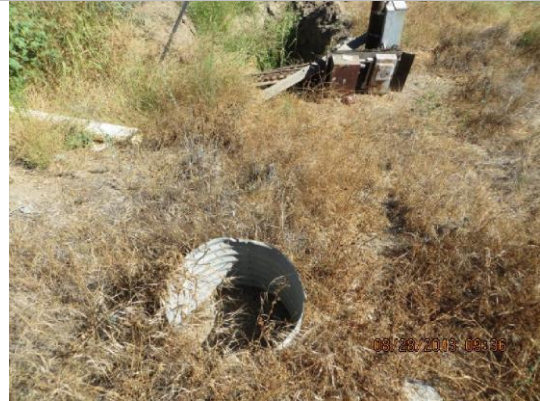
Photo 1 of 3 : UCIP_SP_2019_51385_31892.jpg

Siphon breaker in 24-inch CMP riser on LS shoulder.

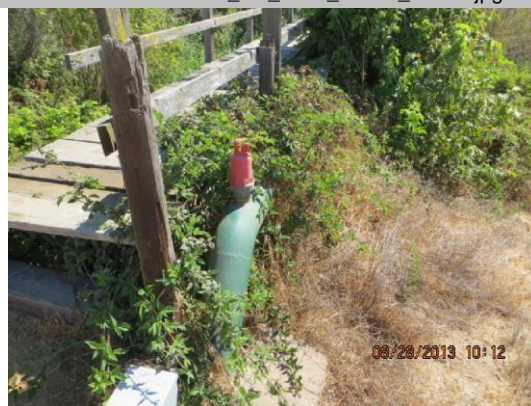
Photo 1 of 3 : UCIP_SP_2019_22095_37722.jpg

Pipe and vent visible on WS shoulder at wooden walkway.

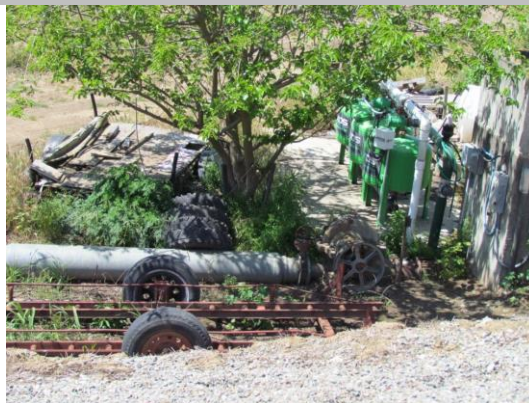
Photo 2 of 2 : SP_2019_RD2064_314_23_20190313_00004.jpg

LM Start	1.97	Rating **	U	Issue No.	23 (cont)	
LM End	1.97	Issue Type +	En	Location *	LS	
Category	Earthen Levee			GPS Latitude/Longitude		
				Start		End
Item	Encroachments			37.676454 °		37.676454 °
				-121.223200 °		-121.223200 °
DWR ID	DWR_RD2064_02_s_2017_23					
Comment Code						
EQ : Equipment						
Inspector Comment						
This equipment and other materials need to be removed from the landside easement.

RD 2064 Landside looking upstream from levee mile 1.97 more equipment and other materials within the easement.

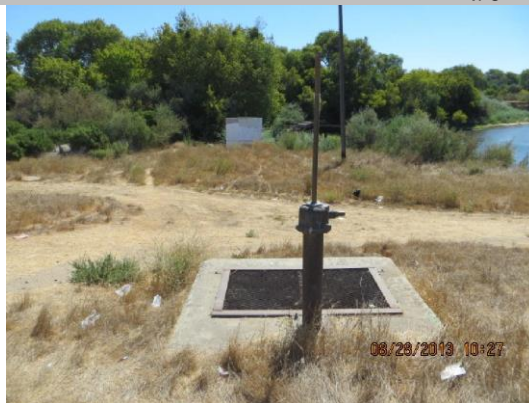
Photo 1 of 3 : UCIP_SP_2019_19086_31954.jpg

Gate valve on WS shoulder. Pump next to concrete riser in background.

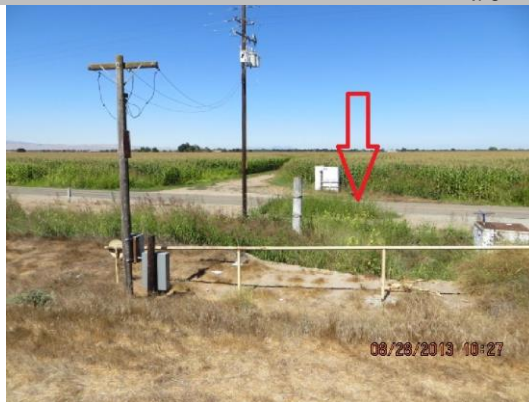
Photo 2 of 3 : UCIP_SP_2019_19086_31953.jpg

Wet area next to roadway off LS toe may indicate a leak. Power pole and meter on LS toe.

Comment Code						
Inspector Comment						
FS_ID:19086 DS_ID:20540 EP_NO: N/A Repair Type: Non-Urgent Crossing Status: Found UCIP Comments: Leak next to roadway may indicate pipe has reached life capacity-good candidate for video inspection. FIELD_STRUCT_DESC: 30-inch by 30-inch reinforced concrete box irrigation culvert through the levee, 14.5 feet below the crown. Pipe reduced to 24-inch through the berm to pump house. Slide gate in a 6-foot by 7-foot concrete riser on the waterside (WS) slope. Slant pump mounted on the berm next to a 5-foot by 9-foot concrete riser. 1.5-inch electrical conduit at the same location. [Additional Reference(s): DWR Levee Log, 2005. USACE San Joaquin O&M Manual 3, December 1968, (HLM 2.51)]. FS Date: 8/28/2013

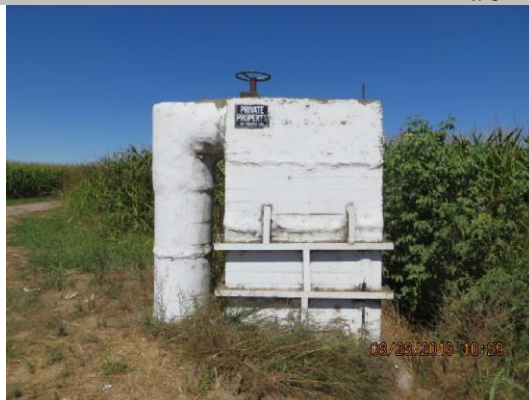
Photo 3 of 3 : UCIP_SP_2019_19086_31952.jpg

Concrete riser in field north of levee likely outlet for cox culvert.

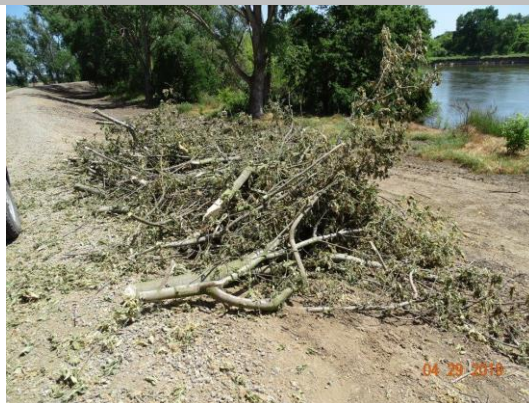
Photo 1 of 1 : SP_2019_RD2064_314_37_20190514_00055.jpg

LM Start	2.77	Rating **	U	Issue No.	37
LM End	2.77	Issue Type +	Ma	Location *	WS
Category	Earthen Levee			GPS Latitude/Longitude	
				Start	End
Item	Encroachments			37.685138 °	37.685138 °
				-121.220125 °	-121.220125 °
DWR ID	DWR_RD2064_02_s_2019_37				
Comment Code					
PR : Prunings					
Inspector Comment					
There is a pruning pile on the waterside shoulder.

View of pruning pile on waterside shoulder obstructing visibility. (Spring 2019)

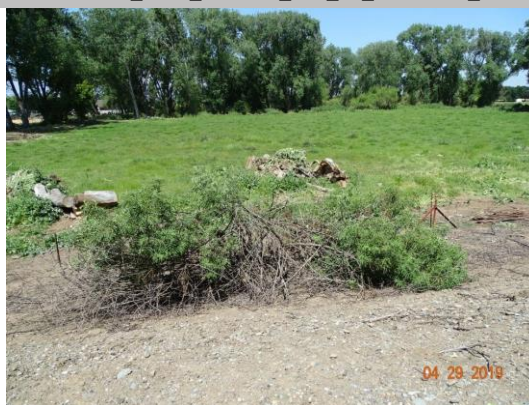
Photo 1 of 1 : SP_2019_RD2064_314_38_20190514_00056.jpg

LM Start	2.84	Rating **	M	Issue No.	38
LM End	2.84	Issue Type +	En	Location *	LS
Category	Earthen Levee			GPS Latitude/Longitude	
				Start	End
Item	Encroachments			37.685977 °	37.685977 °
				-121.219518 °	-121.219518 °
DWR ID	DWR_RD2064_02_s_2019_38				
Comment Code					
PR : Prunings					
Inspector Comment					
There is a pruning pile on the landside shoulder.

View of pruning pile on landside shoulder obstructing visibility. (Spring 2019)

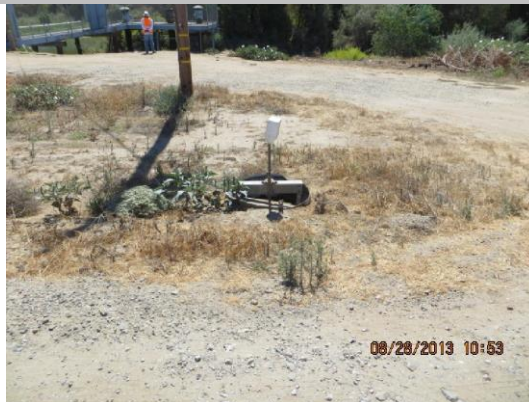
Photo 2 of 3 : UCIP_SP_2019_41075_31962.jpg

LM Start	4.19	Rating **	M	Issue No.	45 (cont)
LM End	4.19	Issue Type +	En	Location *

Slide gate in 36-inch CMP riser on WS slope.

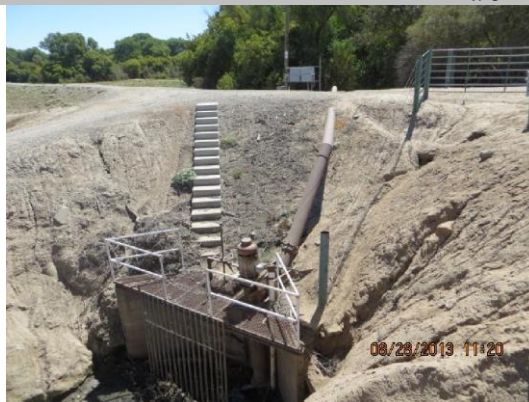
Photo 1 of 2 : UCIP_SP_2019_22107_37736.jpg

LM Start	4.24	Rating **	M	Issue No.	46	
LM End	4.24	Issue Type +	En	Location *		
Category	Supplemental			GPS Latitude/Longitude		
				Start	End	
Item	DWR UCIP Field Study			37.695745 °	37.695745 °	
				-121.205865 °	-121.205865 °	
DWR ID	24064					
Comment Code						
Inspector Comment						
FS_ID:22107 DS_ID:24064 EP_NO: N/A Repair Type: Non-Urgent Crossing Status: Found UCIP Comments: Pipe does not have adequate cover at crown. FIELD_STRUCT_DESC: 12-inch steel discharge pipe through the levee, 0.5 feet below the crown. Pump on concrete headwall at the landside (LS) toe. Pipe discharges into a 6-foot by 7-foot concrete box on the waterside (WS) shoulder. FS Date: 8/28/2013

Pump for pipe on concrete headwall at LS toe.

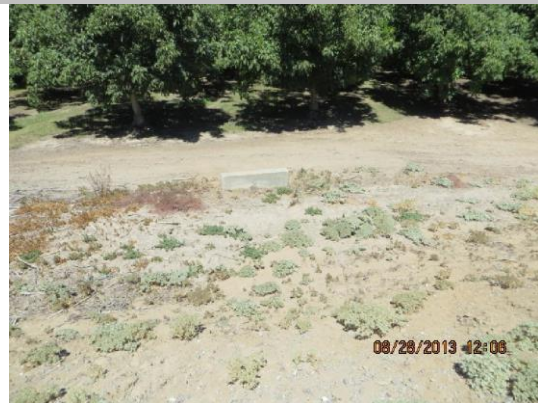
Photo 1 of 3 : UCIP_SP_2019_19117_32069.jpg

LM Start	4.41	Rating **	A/W	Issue No.	47
LM End	4.41	Issue Type +	Ma	Location *	
Category	Supplemental			GPS Latitude/Longitude	
				Start	End
Item	DWR UCIP LMA Responsibility			37.696386 °	37.696386 °
				-121.202963 °	-121.202963 °
DWR ID	20549				
Comment Code					
Inspector Comment					
FS_ID:19117					
DS_ID:20549					
EP_NO: N/A					
Repair Type: No Action Needed					
Crossing Status: Found					
UCIP Comments:					
FIELD_STRUCT_DESC: 30-inch drainage pipe of an unknown material through the levee, 10.5 feet below the crown. Concrete U-shaped headwalls on both ends. Flap gate on the waterside (WS) end. Two corrugated metal cutoff walls. [Additional Reference(s): DWR Levee Log, 2005. USACE San Joaquin O&M Manual 3, December 1968, (HLM 4.37)].					
FS Date: 8/28/2013

Headwall on LS toe.

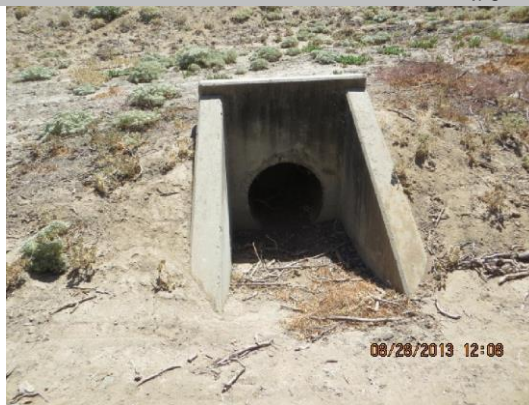
Photo 3 of 3 : UCIP_SP_2019_19117_32067.jpg

Headwall on LS toe.

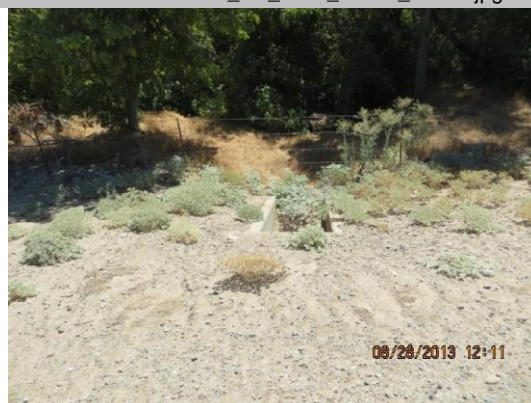
Photo 1 of 3 : UCIP_SP_2019_22793_38842.jpg

LM Start	4.51	Rating **	A/W	Issue No.	48
LM End	4.51	Issue Type +	Ma	Location *	
Category	Supplemental			GPS Latitude/Longitude	
				Start	End
Item	DWR UCIP LMA Responsibility			37.696892 °	37.696892 °
				-121.201228 °	-121.201228 °
DWR ID	20550				
Comment Code					
Inspector Comment					
FS_ID:22793 DS_ID:20550 EP_NO: N/A Repair Type: No Action Needed Crossing Status: Found UCIP Comments: FIELD_STRUCT_DESC: 30-inch corrugated metal drainage pipe through the levee, 8 feet below the crown. Concrete U-shaped headwalls on both ends, and a flap gate on the waterside (WS) end. Grouted spillway on the WS. [Additional Reference(s): DWR Levee Log, 2005. USACE San Joaquin O&M Manual 3, December 1968, (HLM 4.47)]. FS Date: 8/28/2013

Concrete headwall on WS toe.

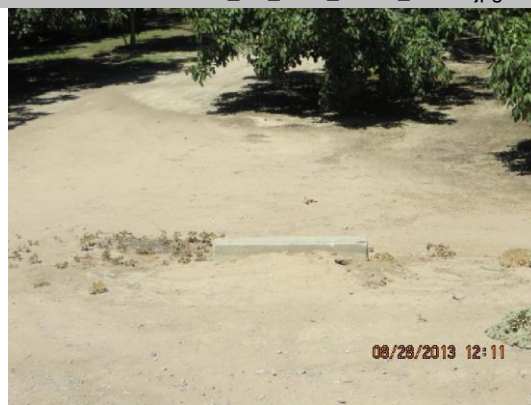
Photo 2 of 3 : UCIP_SP_2019_22793_38841.jpg

Concrete headwall on LS toe.

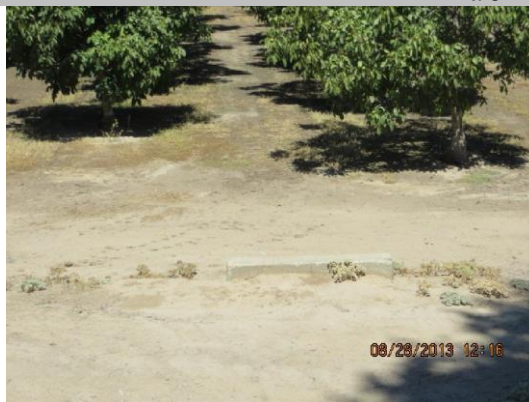
Photo 1 of 3 : UCIP_SP_2019_19120_32079.jpg

LM Start	4.64	Rating **	A/W	Issue No.	49
LM End	4.64	Issue Type +	Ma	Location *	
Category	Supplemental			GPS Latitude/Longitude	
				Start	End
Item	DWR UCIP LMA Responsibility			37.697101 °	37.697101 °
				-121.199048 °	-121.199048 °
DWR ID	20551				
Comment Code					
Inspector Comment					
FS_ID:19120 DS_ID:20551 EP_NO: N/A Repair Type: No Action Needed Crossing Status: Found UCIP Comments: FIELD_STRUCT_DESC: 30-inch corrugated metal drainage pipe through the levee, 10 feet below the crown. Concrete U-shaped headwalls on both ends. Flap gate on the waterside (WS) end. Two corrugated metal cutoff walls. Grouted spillway on the WS. Spillway damaged due to uprooted tree. [Additional Reference(s): DWR Levee Log, 2005. USACE San Joaquin O&M Manual 3, December 1968, (HLM 4.59)]. FS Date: 8/28/2013

Concrete headwall on LS toe.

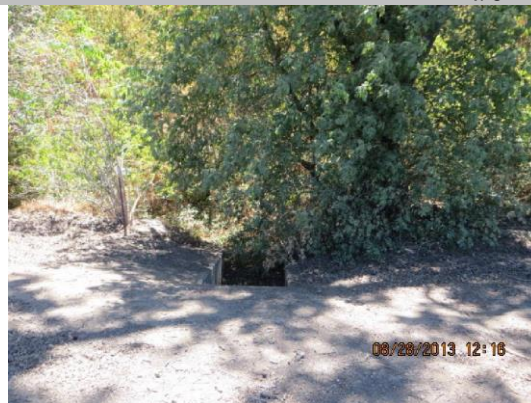
Photo 2 of 3 : UCIP_SP_2019_19120_32078.jpg

Concrete headwall on WS toe.

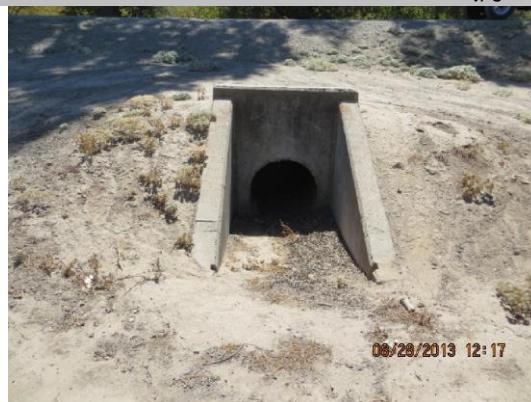
Photo 3 of 3 : UCIP_SP_2019_19120_32077.jpg

Concrete headwall on LS toe.

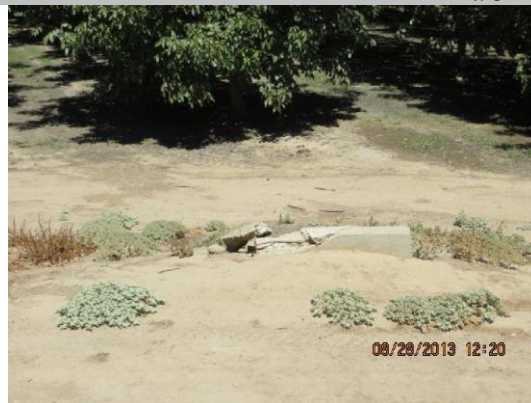
Photo 1 of 3 : UCIP_SP_2019_19122_32083.jpg

LM Start	4.78	Rating **	A/W	Issue No.	50
LM End	4.78	Issue Type +	Ma	Location *	
Category	Supplemental			GPS Latitude/Longitude	
				Start	End
Item	DWR UCIP LMA Responsibility			37.696888 °	37.696888 °
				-121.196511 °	-121.196511 °
DWR ID	20552				
Comment Code					
Inspector Comment					
FS_ID:19122 DS_ID:20552 EP_NO: N/A Repair Type: No Action Needed Crossing Status: Found UCIP Comments: FIELD_STRUCT_DESC: 30-inch corrugated metal drainage pipe through the levee, 8.5 feet below the crown. Concrete U-shaped headwalls on both ends. Flap gate on the waterside (WS) end. Two corrugated metal cutoff walls. Grouted spillway on the WS. [Additional Reference(s): DWR Levee Log, 2005. USACE San Joaquin O&M Manual 3, December 1968, (HLM 4.73)]. FS Date: 8/28/2013

Concrete headwall on LS toe.

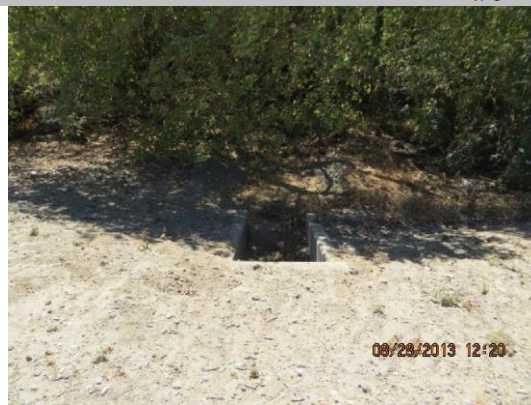
Photo 2 of 3 : UCIP_SP_2019_19122_32082.jpg

Concrete headwall on WS toe.

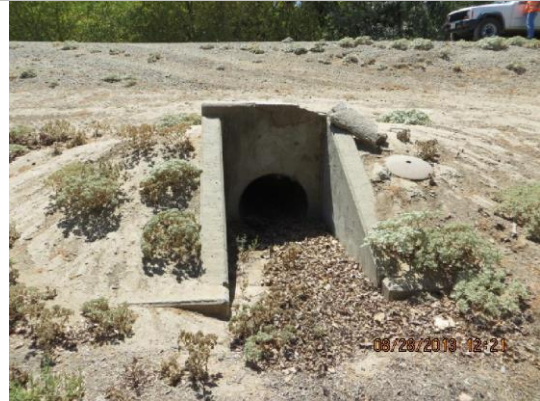
Photo 3 of 3 : UCIP_SP_2019_19122_32081.jpg

Concrete headwall on LS toe.

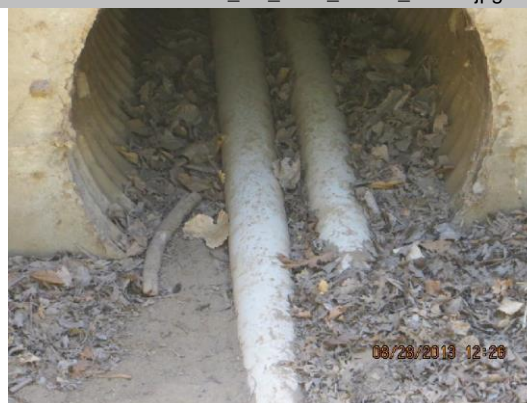
Photo 2 of 3 : UCIP_SP_2019_22108_37738.jpg

LM Start	4.92	Rating **	M	Issue No.	51 (cont)	
LM End	4.92	Issue Type +	En	Location *		
Category	Supplemental			GPS Latitude/Longitude		
				Start	End	
Item	DWR UCIP Field Study			37.696146 °	37.696146 °	
				-121.194093 °	-121.194093 °	
DWR ID	24065					
Comment Code						
Inspector Comment						
FS_ID:22108 DS_ID:24065 EP_NO: N/A Repair Type: Non-Urgent Crossing Status: Found UCIP Comments: No permit identified for this discharge pipe. FIELD_STRUCT_DESC: 1 of 2: 4-inch polyvinyl chloride (PVC) discharge pipe through the 30-inch drainage pipe, 11 feet below the crown. No permit. FS Date: 8/28/2013

PVC pipe at right inside stormdrain on LS toe.

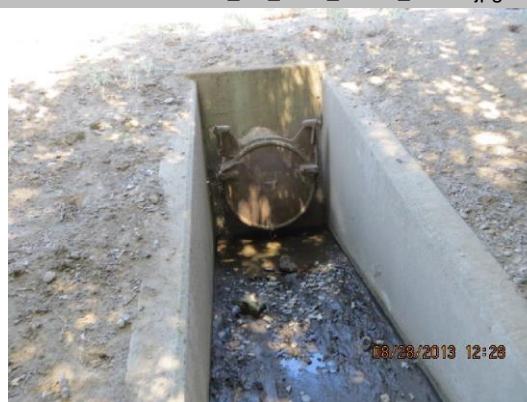
Photo 3 of 3 : UCIP_SP_2019_22108_37737.jpg

Evidence of discharge through PVC conduit on WS toe.

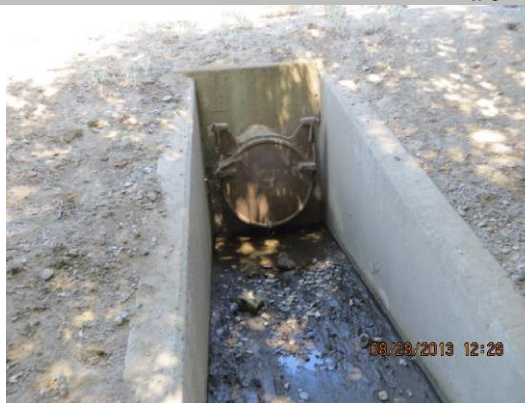
Photo 3 of 3 : UCIP_SP_2019_22109_37740.jpg

LM Start	4.92	Rating **	M	Issue No.	52 (cont)	
LM End	4.92	Issue Type +	En	Location *		
Category	Supplemental			GPS Latitude/Longitude		
				Start	End	
Item	DWR UCIP Field Study			37.696146 °	37.696146 °	
				-121.194093 °	-121.194093 °	
DWR ID	24066					
Comment Code						
Inspector Comment						
FS_ID:22109 DS_ID:24066 EP_NO: N/A Repair Type: Non-Urgent Crossing Status: Found UCIP Comments: No permit identified for this crossing. FIELD_STRUCT_DESC: 2 of 2: 4-inch polyvinyl chloride (PVC) discharge pipe through the 30-inch drainage pipe, 11 feet below the crown. No permit. FS Date: 8/28/2013

Evidence of discharge from PVC on WS toe.

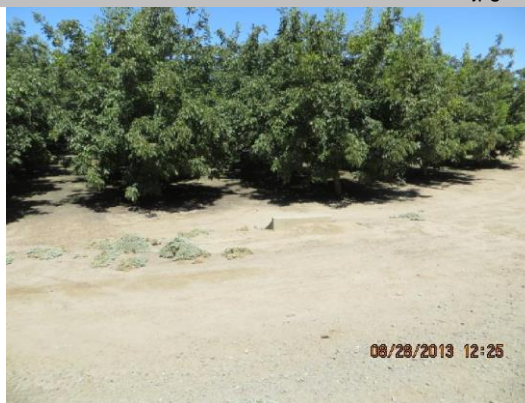
Photo 1 of 3 : UCIP_SP_2019_19143_32122.jpg

LM Start	4.92	Rating **	A/W	Issue No.	53
LM End	4.92	Issue Type +	Ma	Location *	
Category	Supplemental			GPS Latitude/Longitude	
				Start	End
Item	DWR UCIP LMA Responsibility			37.696146 °	37.696146 °
				-121.194093 °	-121.194093 °
DWR ID	20553				
Comment Code					
Inspector Comment					
FS_ID:19143 DS_ID:20553 EP_NO: N/A Repair Type: No Action Needed Crossing Status: Found UCIP Comments: FIELD_STRUCT_DESC: 30-inch corrugated metal drainage pipe through the levee, 8 feet below the crown. Concrete U-shaped headwalls on both ends. Flap gate on the waterside (WS) end. Two corrugated metal cutoff walls. Grouted spillway on the WS. [Additional Reference(s): DWR Levee Log, 2005. USACE San Joaquin O&M Manual 3, December 1968, (HLM 4.88)]. FS Date: 8/28/2013

Concrete headwall on LS toe.

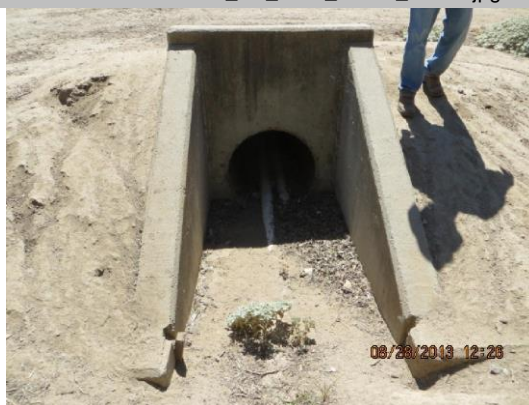
Photo 3 of 3 : UCIP_SP_2019_19143_32120.jpg

Concrete headwall on LS toe.

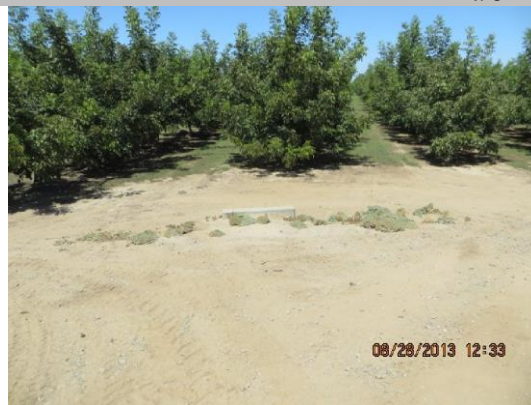
Photo 2 of 3 : UCIP_SP_2019_22794_38850.jpg

Concrete headwall on LS toe.

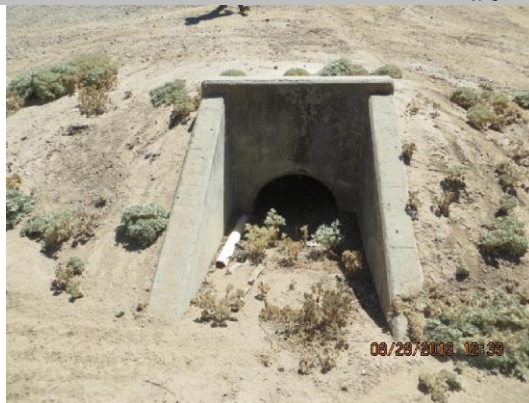
Photo 3 of 3 : UCIP_SP_2019_22794_38853.jpg

Concrete headwall on LS toe.
